MOZAMBIQUE - MUDA DAM

MBB designed and supervised the construction of an earthfill dam with a wall height of 32m, that impounds 56,5 million m³ of water.

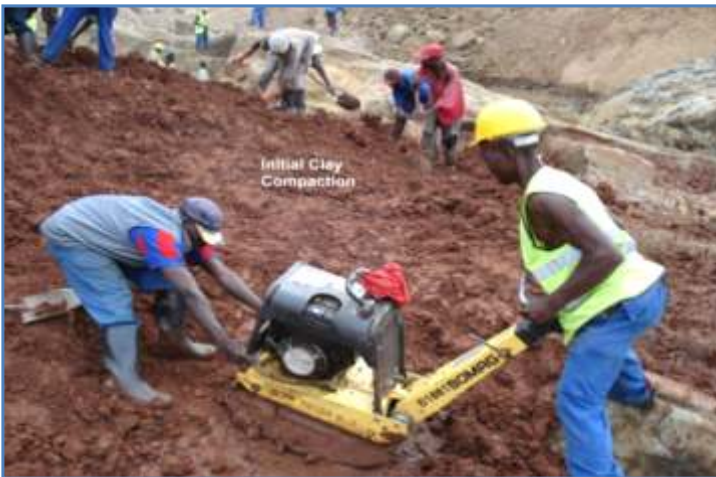
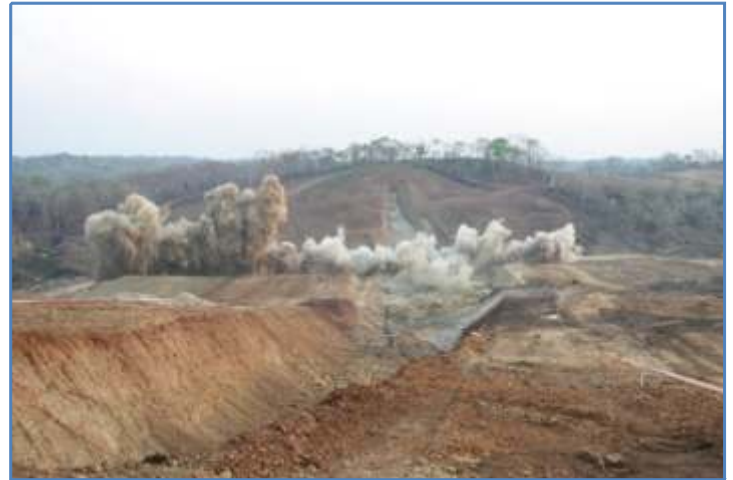
Good quality clays for the core were sourced from within 800m of the embankment. As the dam started filling before the embankment could be completed, additional downstream borrow areas had to be found, as the original borrows were now flooded.

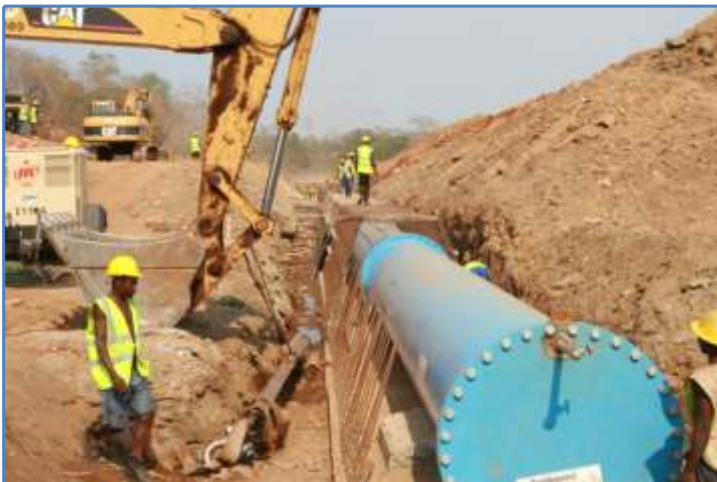
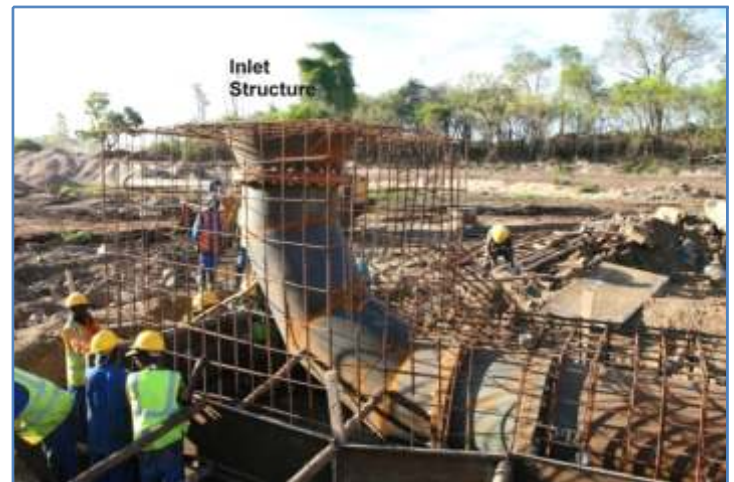
The 1200Ø steel outlet pipe is founded on rock along its length and is encased in reinforced concrete.

A 900Ø sleeve valve and a 350Ø needle valve have been fitted as control valves while a 1 000Ø gate valve has been installed for emergency situations and for maintenance purposes.

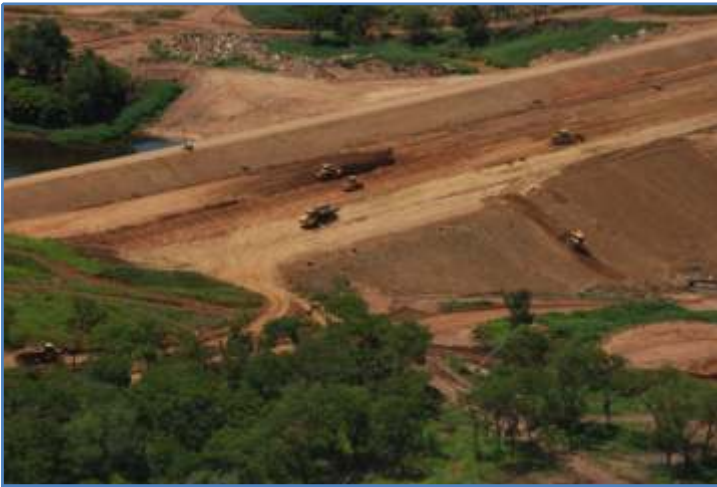
The spillways were designed to have three different levels. Both the primary and secondary spillways have hard rock across their width.

Concrete sills have also been installed in all three of the spillways, so as to minimize possible erosion.

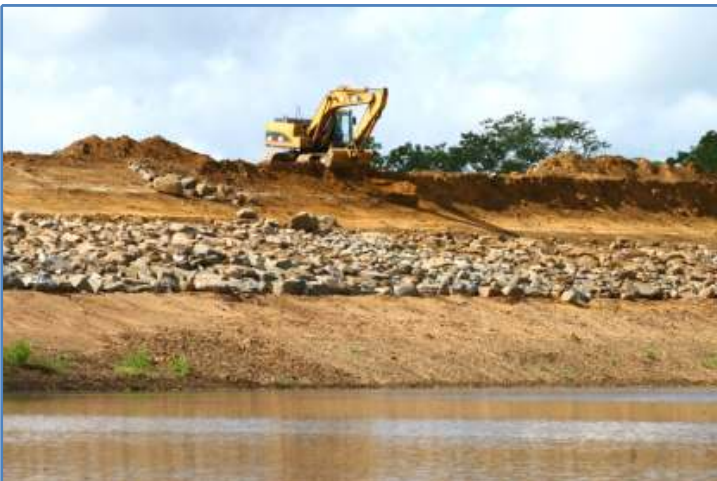
To protect the works from possible flood damage a 60m wide emergency spillway was excavated and the front face of the main embankment was built up to provide 3m of freeboard.

This then allowed the contractor to work safely on the rear section of the embankment and would allow flood waters to pass through the emergency spillway.
